**ICA PROJECT 436**

**RESISTANCE OF 90/10 COPPER/NICKEL  
BOAT SHEATHING AND FISH CAGE MESH  
TO FOULING AND CORROSION**

**FINAL REPORT OCTOBER 1995**

Hector S Campbell

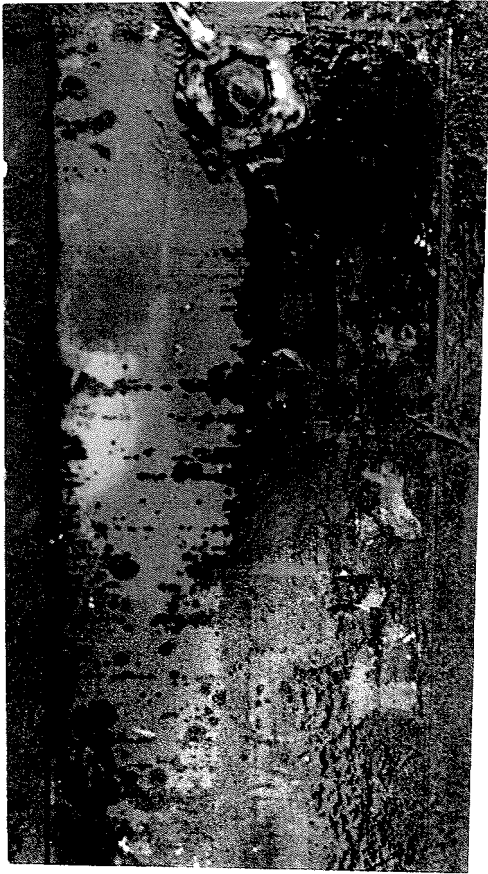
1A. Outward facing

The type of film developed on F1 during exposure depended upon the initial surface condition of the material as illustrated in Figure 1A. The part of the specimen which carried an air-formed tarnish film formed a green film during exposure whereas the part which had been abraded to bright metal formed a brown film. It has been noticed in examining F1/F2 sheathing on boats on which it is performed satisfactorily that some panels formed a green protective film while others formed an equally protective brown film. It appears probable that this difference is the result of differences in the initial condition of the panels before they were applied to the hull, as a result of variation in storage conditions (eg time of storage and whether the panel was wrapped, in the middle of a pile or exposed to the atmosphere) producing differences in the extent to which the panels had tarnished. It is suggested that bright panels produced a brown film while tarnished panels produced a green film.

Figure 1. Back-to-back samples of F1 sheathing: Emsworth.

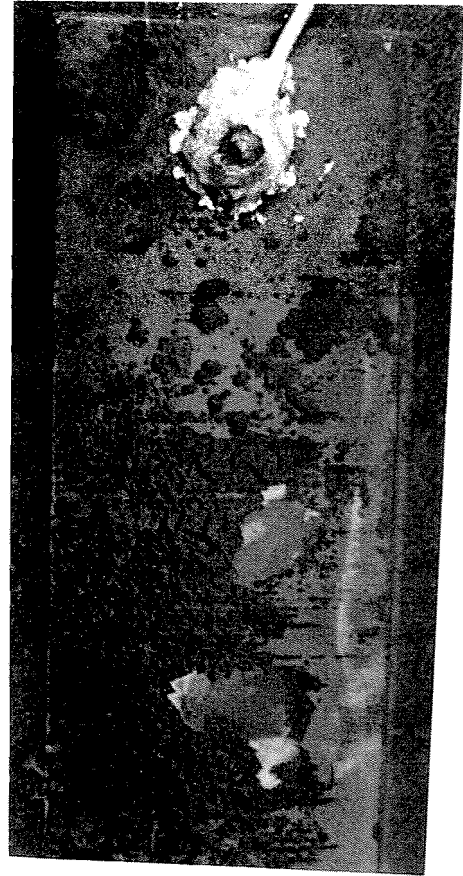
1B. Inward facing

No F3 sheathing had been available for exposure at Emsworth. The F1 and F2 samples all developed very poorly adherent brown films beneath slimy organic deposits. The films were not protective; they were easily removed by rubbing with the finger, revealing a bright etched metal surface or loose red crystalline cuprous oxide beneath.

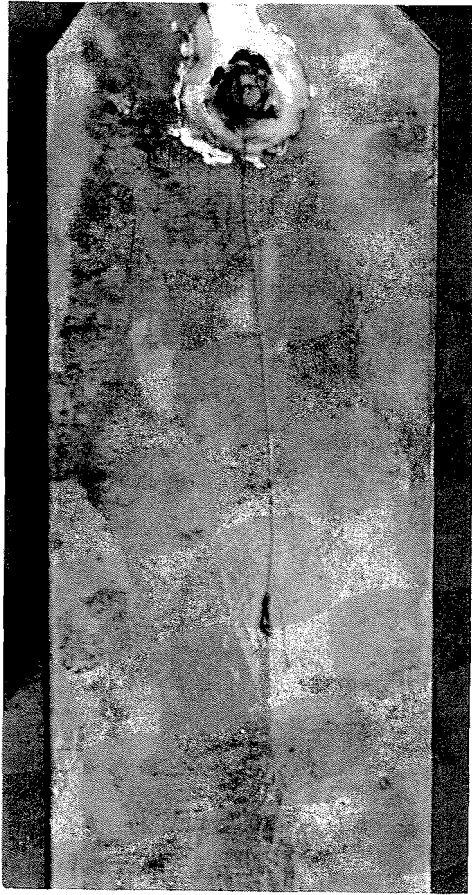
2A. Outward facing

The results of the back-to-back sample tests at Emsworth show very clearly that, whereas material with the correct iron content of 1.5%, with the iron in solution (sheathing F4), forms a fully protective film under both fully exposed and shielded exposure conditions, material containing only 0.7% iron is unreliable under fully exposed conditions and liable to serious corrosion under shielded exposure conditions.

Figure 2. Back-to-back samples of F4 sheathing: Emsworth.

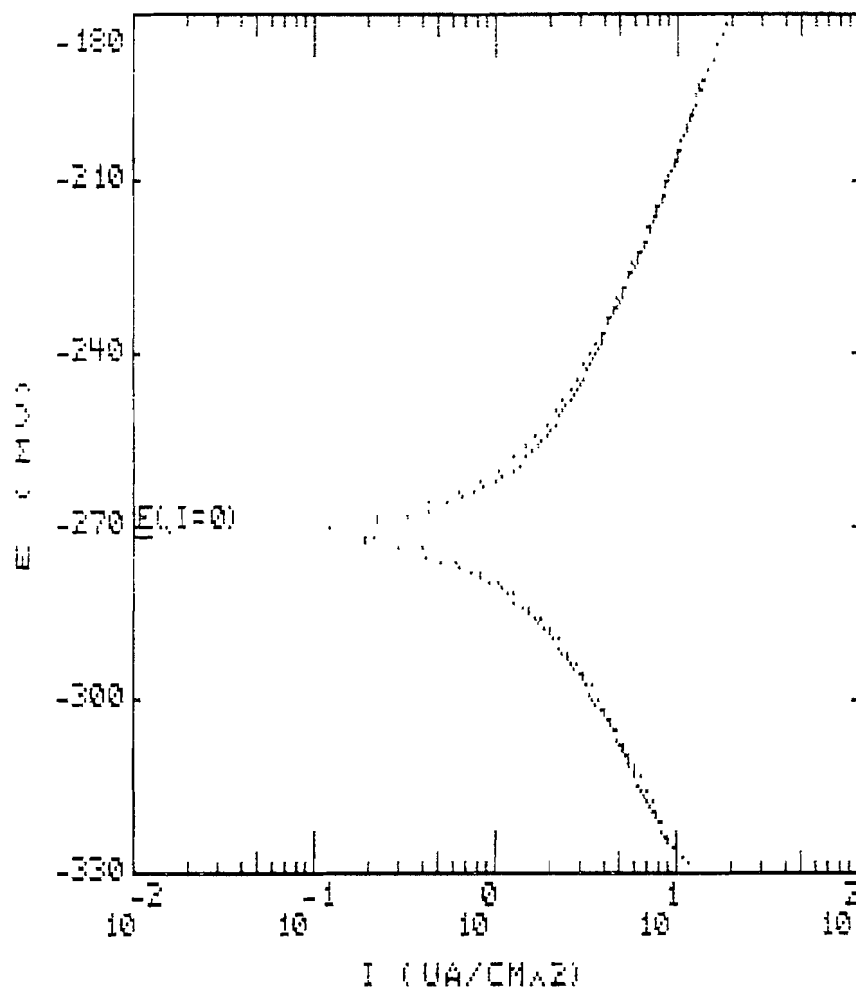
Figure 3. Tafel scan and calculated Tafel points for Sample F1 5.

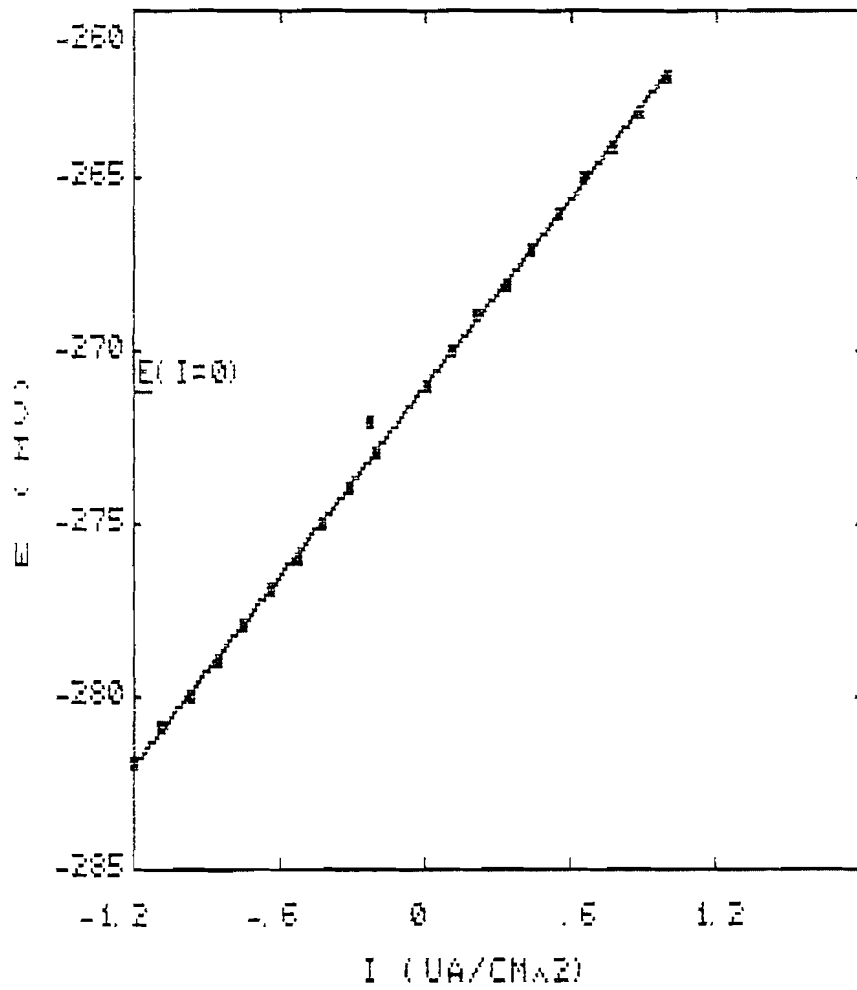
Figure 4. Polarisation resistance plot and calculated best-fit for Sample F1 5.
